REHABILITATION OF A STEEL PENSTOCK

BY: ROBERT A. JAMES, ROGER L. INMAN, MARK S. PETERSON,
THOMAS L. KAHL, AND KEITH MARTIN

ABSTRACT

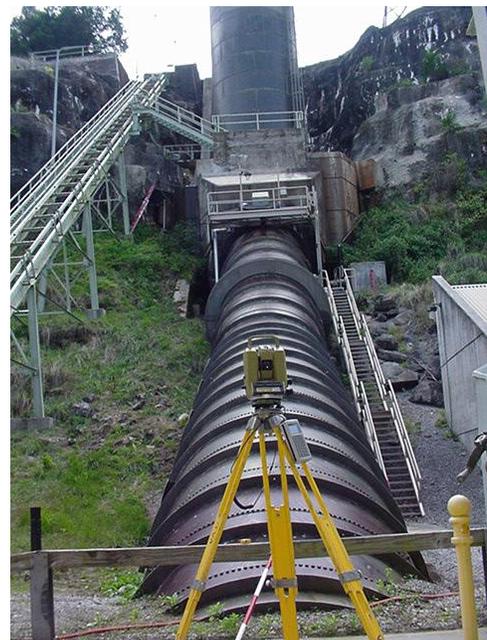
FIGURE 1 ABOVE GROUND PENSTOCK
BEFORE REPLACEMENT

Although these penstocks had operated reliably for nearly 80 years, TVA's proactive maintenance and inspection program identified an area of concern: the shell thickness readings for the Unit 1 penstock showed steel thinning. Calculations were performed which revealed unacceptable stresses in the steel for some loading conditions.

powerhouse. **Figure 1** is looking upstream at Unit 1 from the powerhouse.

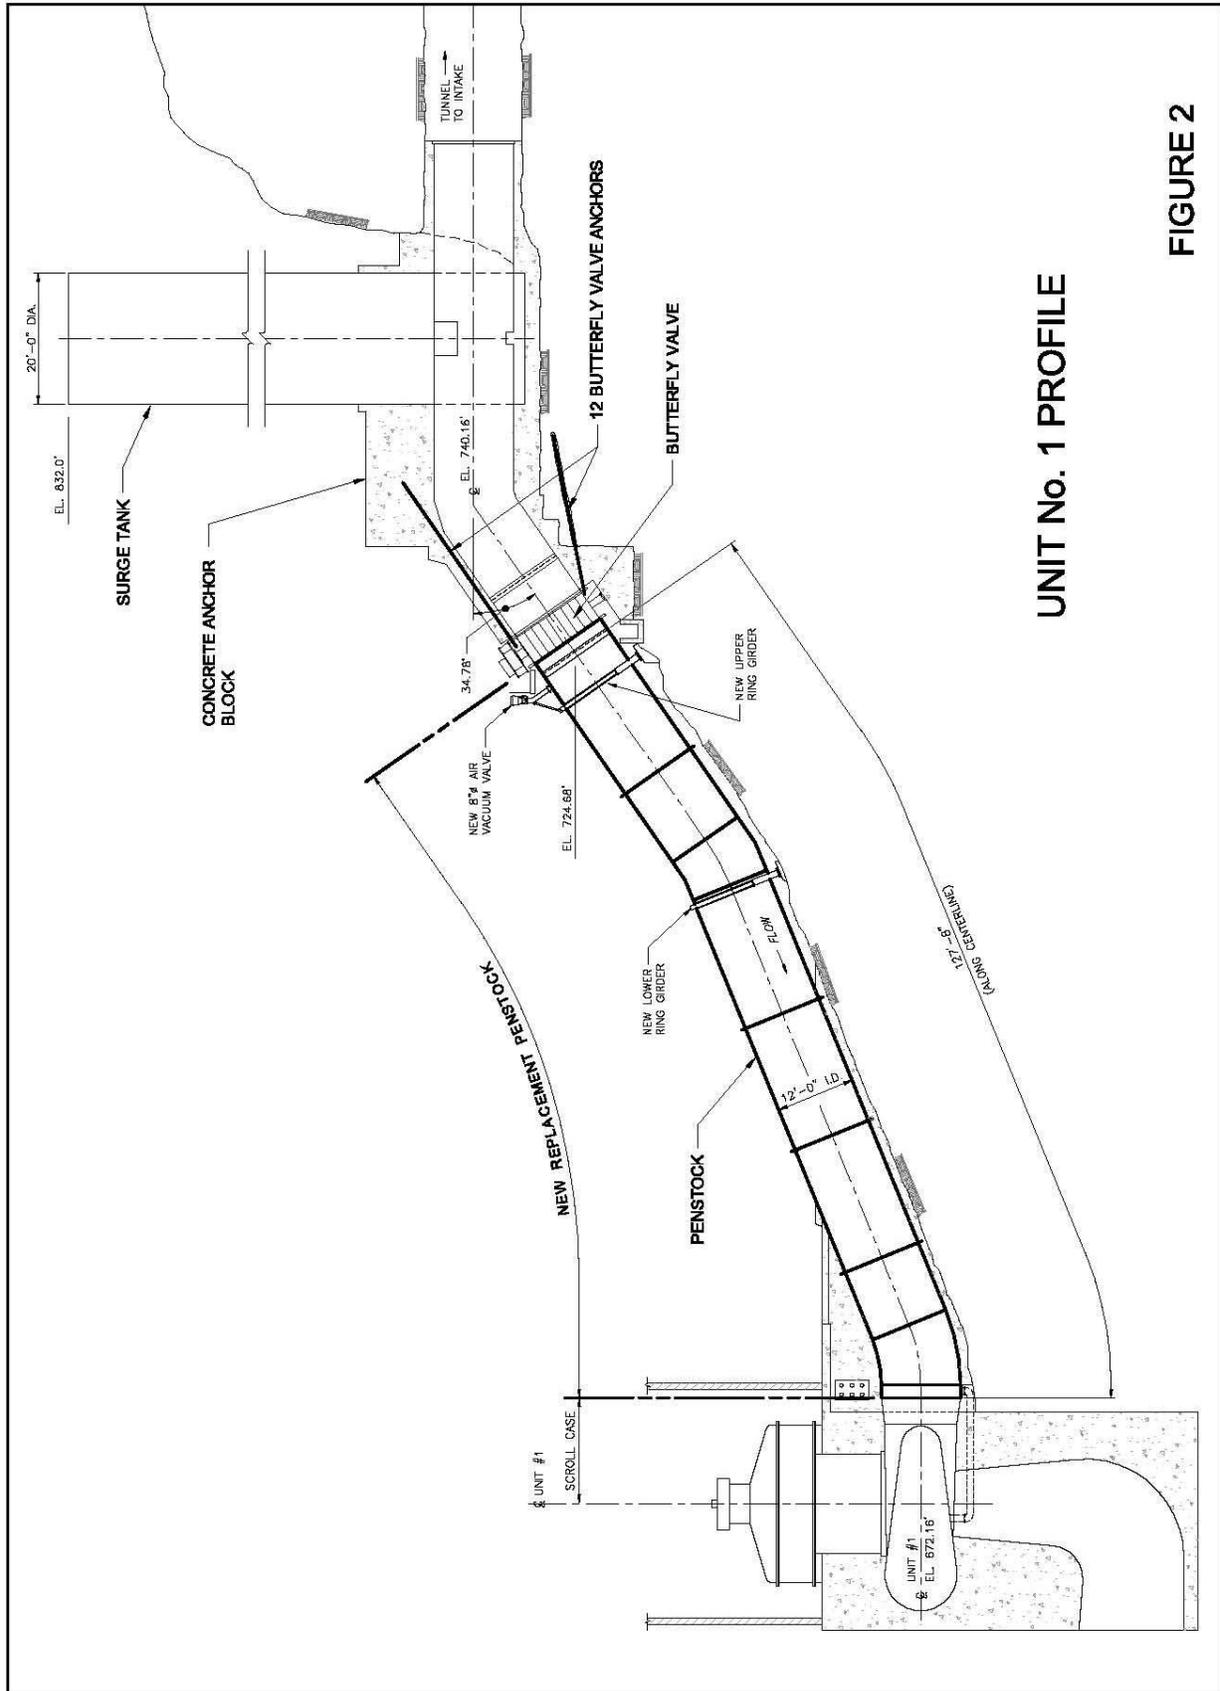
FIGURE 2

In late November 2004, TVA solicited bids for construction of the project. At that time, it was found that estimated construction costs far exceeded the project budget due to the amount of rock excavation that was required for the new layout using one vertical bend. Therefore, it was decided to revert to the existing configuration using two vertical bends. Although this change was made late in the process, it did not have significant impact on the project. The design thickness of the steel did not change, and fabrication of the new penstock had not begun. **Figure 2** shows the final profile of the Unit 1 replacement penstock and location of the other primary water passage features.

UNIT No. 1 PROFILE

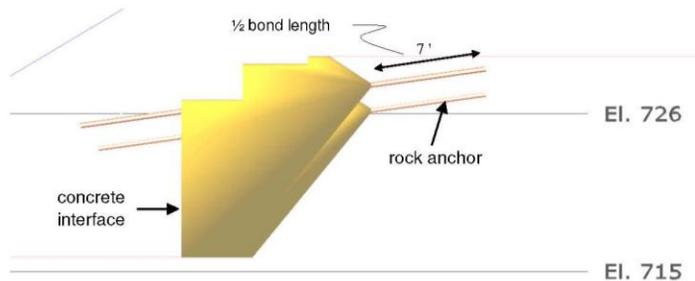
Image 1 - Profile view of Unit 1 rock anchorage, showing engaged rock mass cones developed by the four rock anchors

The results of the evaluation indicated a factor of safety against rock mass anchor pullout of 12.4 for the Unit 1 anchors, and 6.9 for the Unit 2 anchors. Both values exceeded the minimum recommended safety factor of 3.0.

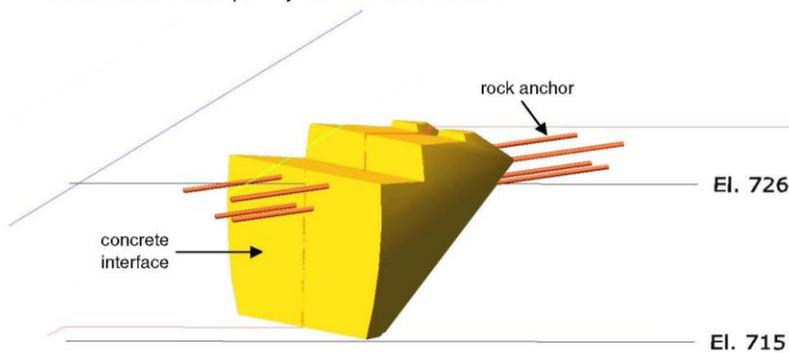
Image 2 - Oblique front view of Unit 1 engaged rock mass anchorage

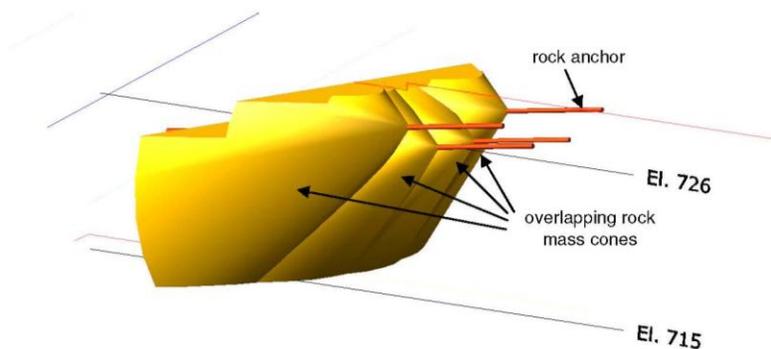
Image 3 - Oblique rear view of Unit 1 engaged rock mass anchorage

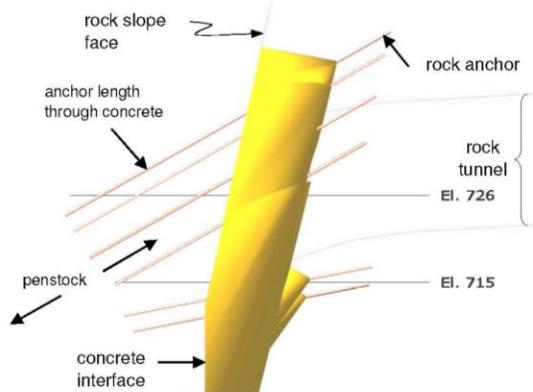
Image 5 - Oblique front view of Unit 2 engaged rock mass anchorage

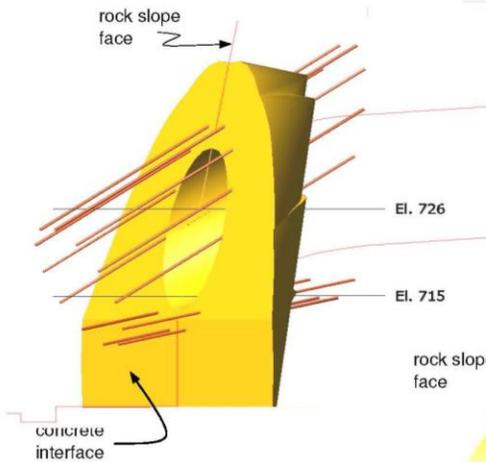
Image 6 - Oblique rear view of Unit 2 rock anchorage, showing engaged rock mass cones developed by 12 rock anchors

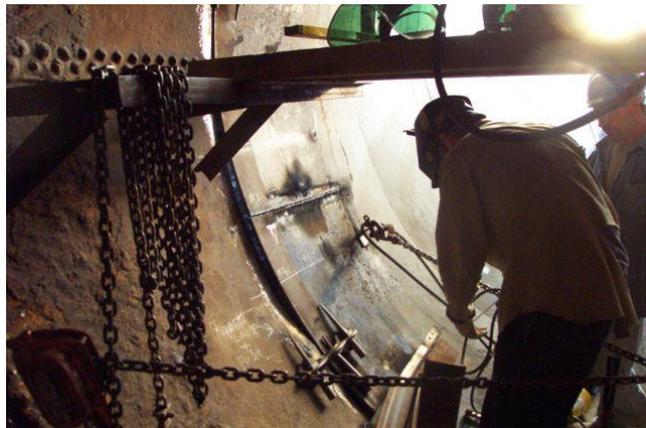
FIGURE 5 FIRST FIT-UP SLIT CUT

Fit-up at Powerhouse – Fit-up between the new penstock and the old penstock at the face of the powerhouse was a problem when the circumferences did not align perfectly. To resolve this problem, Kleinschmidt recommended cutting longitudinal slits in the new penstock to allow the circumference of the new penstock to be adjusted to match the circumference of the old penstock. The slits were then welded back together with full penetration welds. Five slits were

cut, and the alignment method worked well. **Figure 5** shows the first fit-up slit cut.

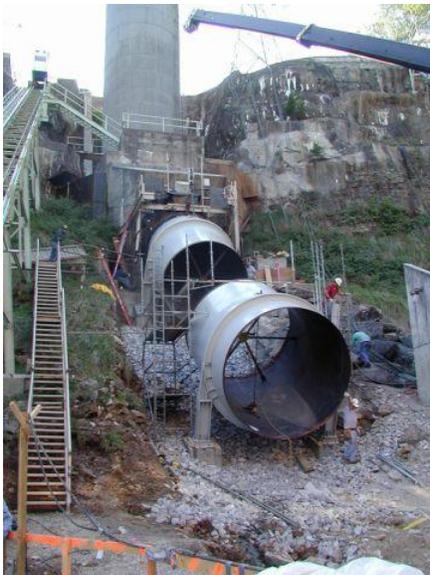
FIGURE 6 PENSTOCK INSTALLATION

Fit-up Between Penstock Sections – The installation was intended to use fit-up strap plates which would cover the gap at the joints between penstock sections. The constructor requested that the strap be made in two pieces with one piece being shop-welded to the bottom of one penstock section and with the other piece of the strap plate shop-welded to the top half of the adjacent section that would join with it. This would allow the strap to serve as a support for the adjacent penstock section. These straps had dog ears that could be bolted together until the field welds were made that would join the penstock sections together via the straps. This worked adequately as long as the gap between penstock sections remained as designed. But when the gap could not be accurately obtained because of field adjustment tolerances, the straps and their bolt holes were no longer in alignment. Therefore, the top piece of the shop-welded strap had to be removed and realigned. There also was a problem with welding the straps together at the equator of the penstock. The straps did not quite meet, and a small piece had to be welded between the ends of the straps to fill the gap. **Figures 6** and **7** show penstock installation and completion.

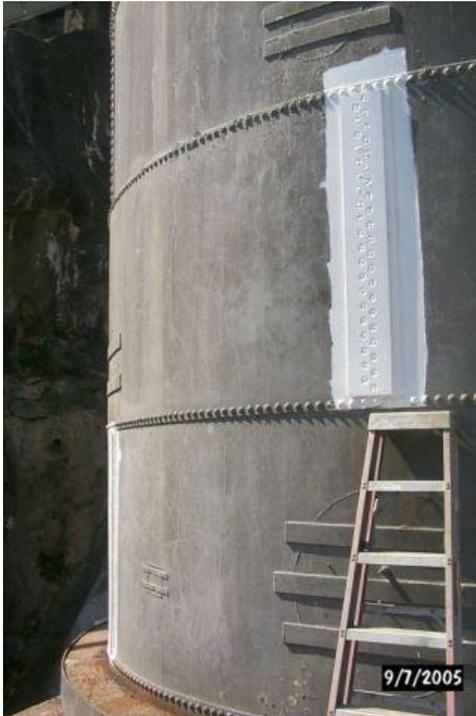
FIGURE 8 SURGE TANK REPAIR

During the surge tank analysis, an unexpected result was discovered. When the shell's longitudinal rivet efficiency of 73 percent was taken into account, three of the lower five-foot high courses of the existing tank shell did not meet the ASCE Manual No. 79 factor of safety for normal internal pressures.

The repair for the two higher shell courses above the surge tank's foundation involved welding reinforcing plates to the shell at the riveted longitudinal joints. The reinforcing plates were designed to have holes drilled to clear the existing rivet heads so that the plates could fit tightly against the tank exterior.

Prior to fabrication of the surge tank repair plates, a paper template of the rivet reinforcement plate was prepared to verify that the holes in the plate would fit over the rivet heads. There was concern that the rivets may not have been uniformly placed and the rivet heads would prevent the plate from fitting correctly. The template showed no problems, and the final plates did fit well during construction. However the strap plate that was added to confine the concrete around the surge tank did not fit tightly. Sika Dur Lo Mod LV cement was used to fill the gaps between the strap and concrete and provide a uniform contact surface. **Figure 8** shows the reinforcing plate. The strap plate also can be seen in the bottom left of the photo.
