REHABILITATION OF A STEEL PENSTOCK

BY: ROBERT A. JAMES, ROGER L. INMAN, MARK S. PETERSON,
THOMAS L. KAHL, AND KEITH MARTIN

ABSTRACT

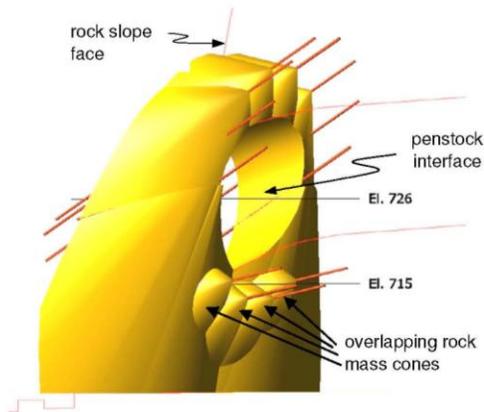
FIGURE 4

INTERPRETED UNIT 2 BUTTERFLY VALVE ROCK MASS ANCHORAGE

The results of the evaluation indicated a factor of safety against rock mass anchor pullout of 12.4 for the Unit 1 anchors, and 6.9 for the Unit 2 anchors. Both values exceeded the minimum recommended safety factor of 3.0.
